REMEDIATION OF FIRE-INDUCED HYDROPHICITY HEAP'S PEAK – SAN BERNARDINO NATIONAL FOREST

MESA VERDE RESOURCES
August 1, 2004

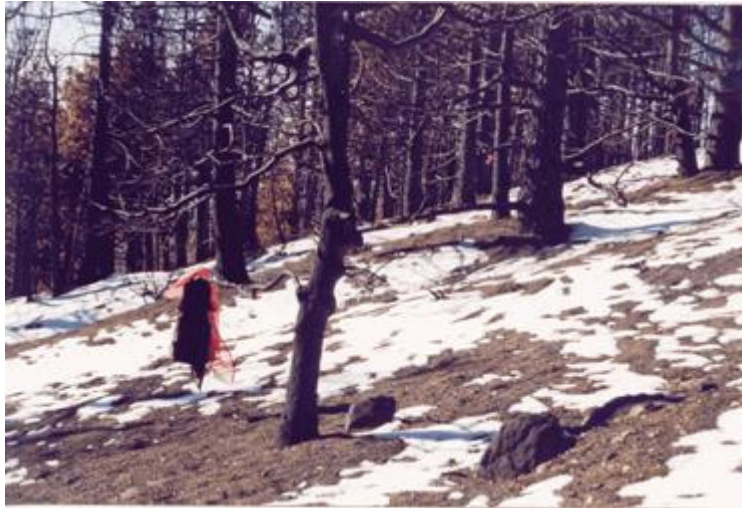
Site just prior to treatment

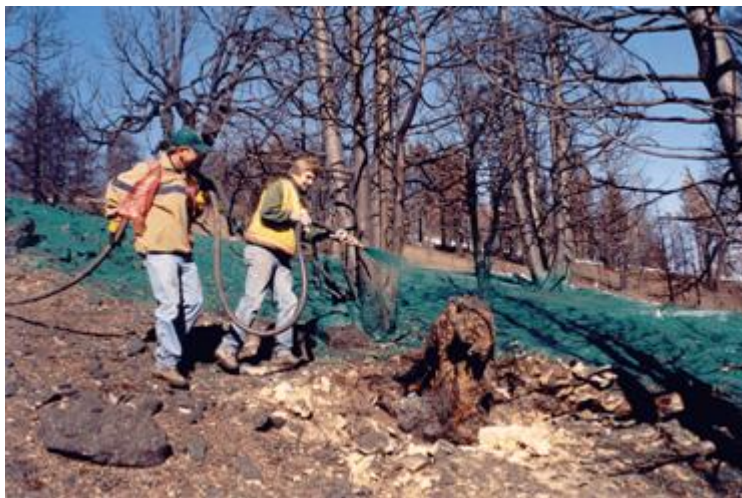
Applying Hydromulch

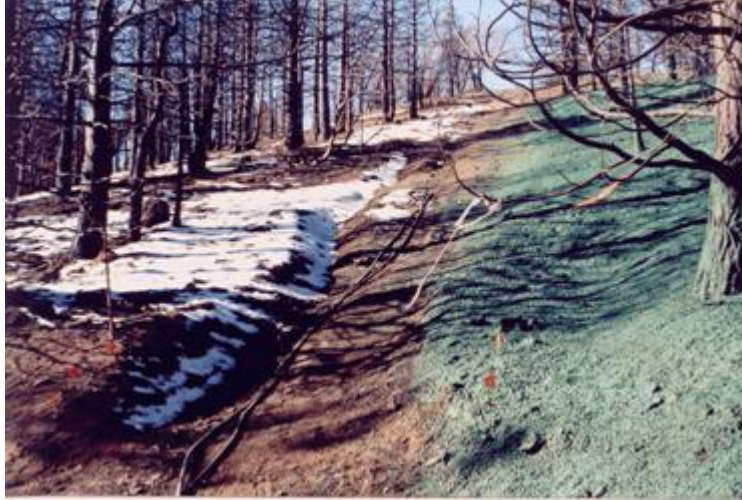
Control Area – left, Treated Area – right

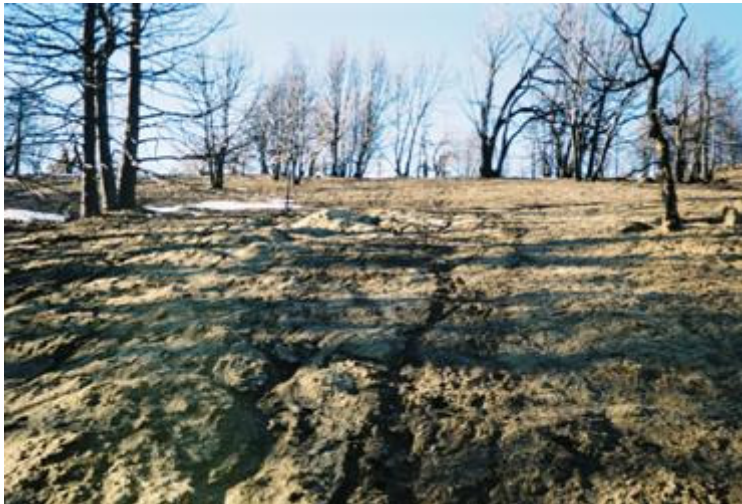
Rilling from heavy rains

Soil stabilization was good throughout most of the project during the test period, mid-December through April, demonstrating the performance of the Fiber Marketing hydro-mulch. Heavy rains during late January caused moderate rilling along the NE part of the project.

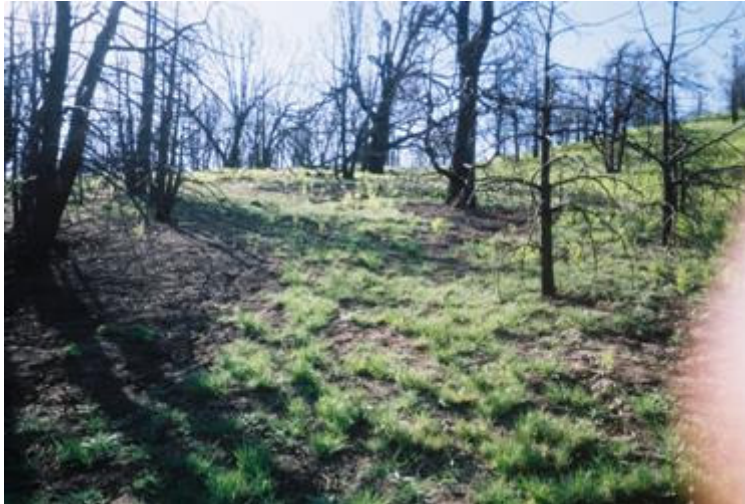
April, 2004 – vegetation established in open areas away from clusters of burned trees

Re-growth of native vegetation by April of 2004 was good in the upper slope and mid-slope areas, particularly away from burned trees or clusters of trees. The lower slope area (originally heavily treed) was still bare for the most part, which we believe was related to the severity of the burn in that area destroying native seeds and roots. The amount of vegetation cover did not appear to be a function of whether or not the ground was treated. The severity of initial burn was interpreted to have been the major control at that point in time, as non-treed areas regenerated more rapidly.

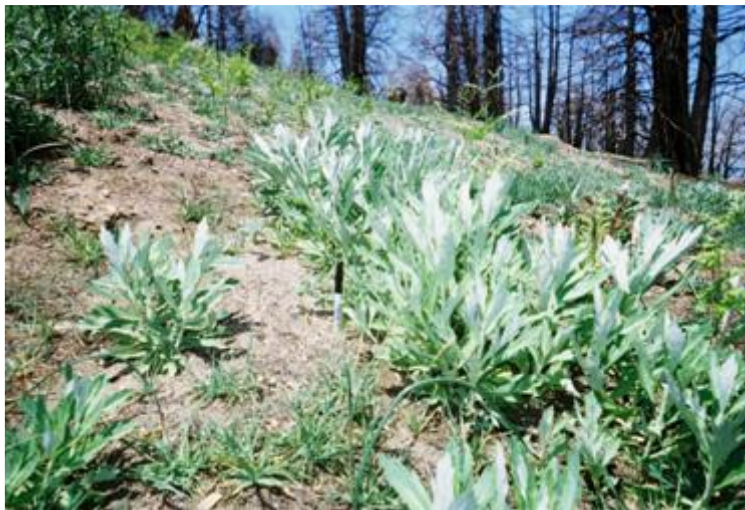
April, 2004 – vegetation in open areas

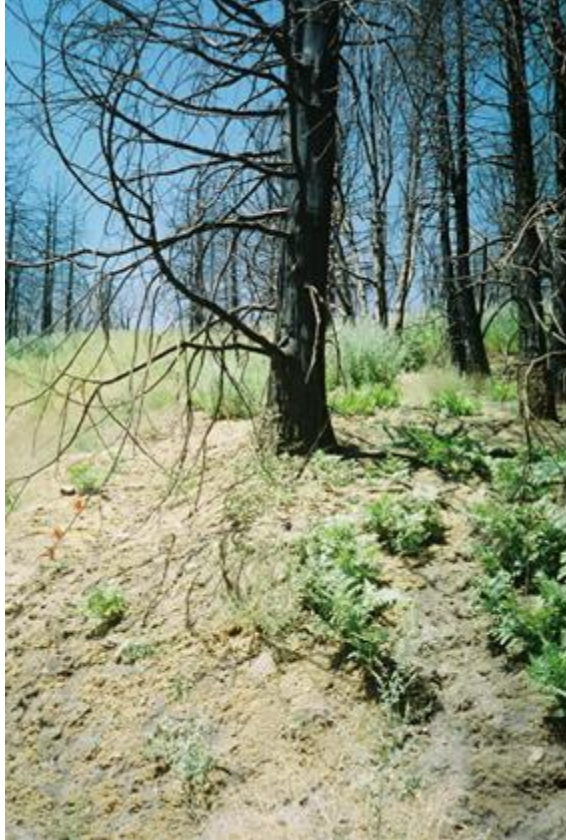
Vegetation in Inoculated Humate area – control on left
